Renovating Residential HVAC Systems HVAC Systems

J.A. McWilliams and I.S. Walker

April 2005

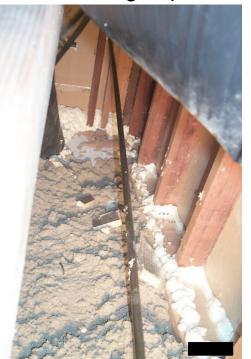
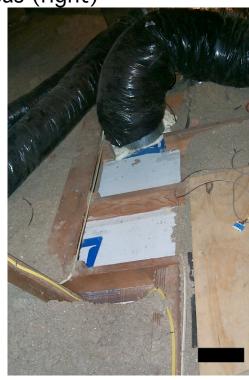
Figure 1. Sealing cavities connecting the house to the attic. Foam was used for sealing small holes and cracks at building component intersections (left). Duct board insulation was used to block off large open areas (right)

the economizer damper was not installed squarely. The sealing of the envelope was very successful—mostly because this particular house had significant large leaks that we were able to access. We sealed over 0.566 m³/s (1,200 CFM) of leakage at 50 Pa, about one-quarter of the total leakage. The sealing included air-sealing the attic floor plane (2 large chases shown in Figure 1), the old cavity return (shown in Figure 2), and plumbing penetrations.

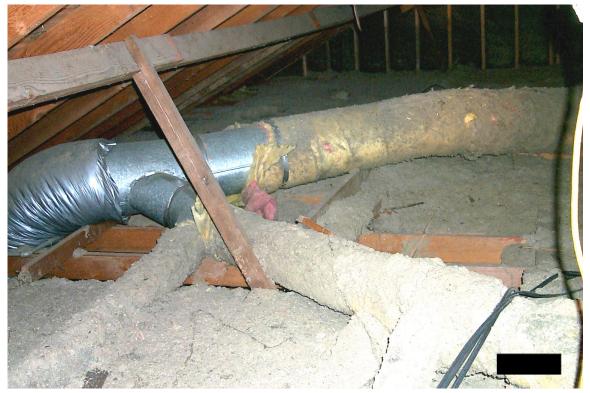
Figure 3. Poorly insulated sheet metal ducts and blown-in insulation in the attic before retrofit

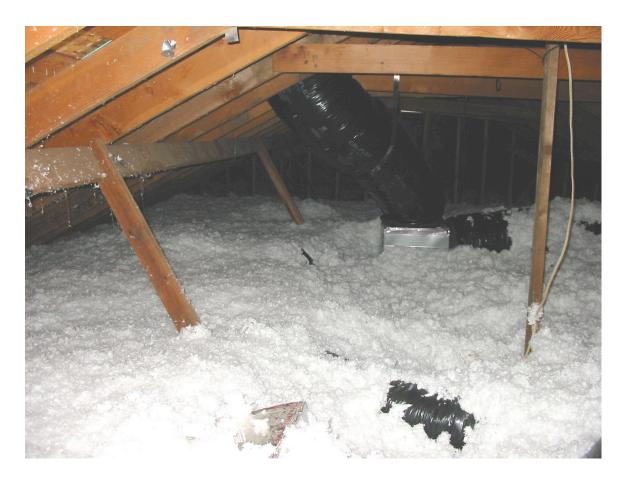
Figure 4. New flex ducts in attic covered by additional blown-in insulation after the retrofit.

- The metal ducts in the attic were replaced with new R-4 flexible ducts (despite clear and repeated instruction to retain the original ducts) because the contractor thought they were undersized. Initially the contractor hung the flex-ducts from the attic ceiling with smooth bends. However, since the ducts would be covered with insulation, the contractor placed the new ducts on the floor, but unfortunately did not take the time to lay the ducts with smooth bends. The use of flex duct increased the system air flow resistance (that contributes to noise, extra air handler power consumption and possibly too low a flow through the furnace and air conditioner). This problem was made worse by the many extra bends in the flex duct due to poor layout.
